International Conference organized by WALMI at Delhi 18 & 19<sup>th</sup> May, 2017 Invited talk on

#### "Exploration in search of incessant Ganga: A social and environmental assessment to resolve erosion and siltation issues"

Presentation by Dr Snehal S Donde Principal, Shri Halari Visa Oswal Degree College & Chief Research Officer Goverdhan Eco-Village

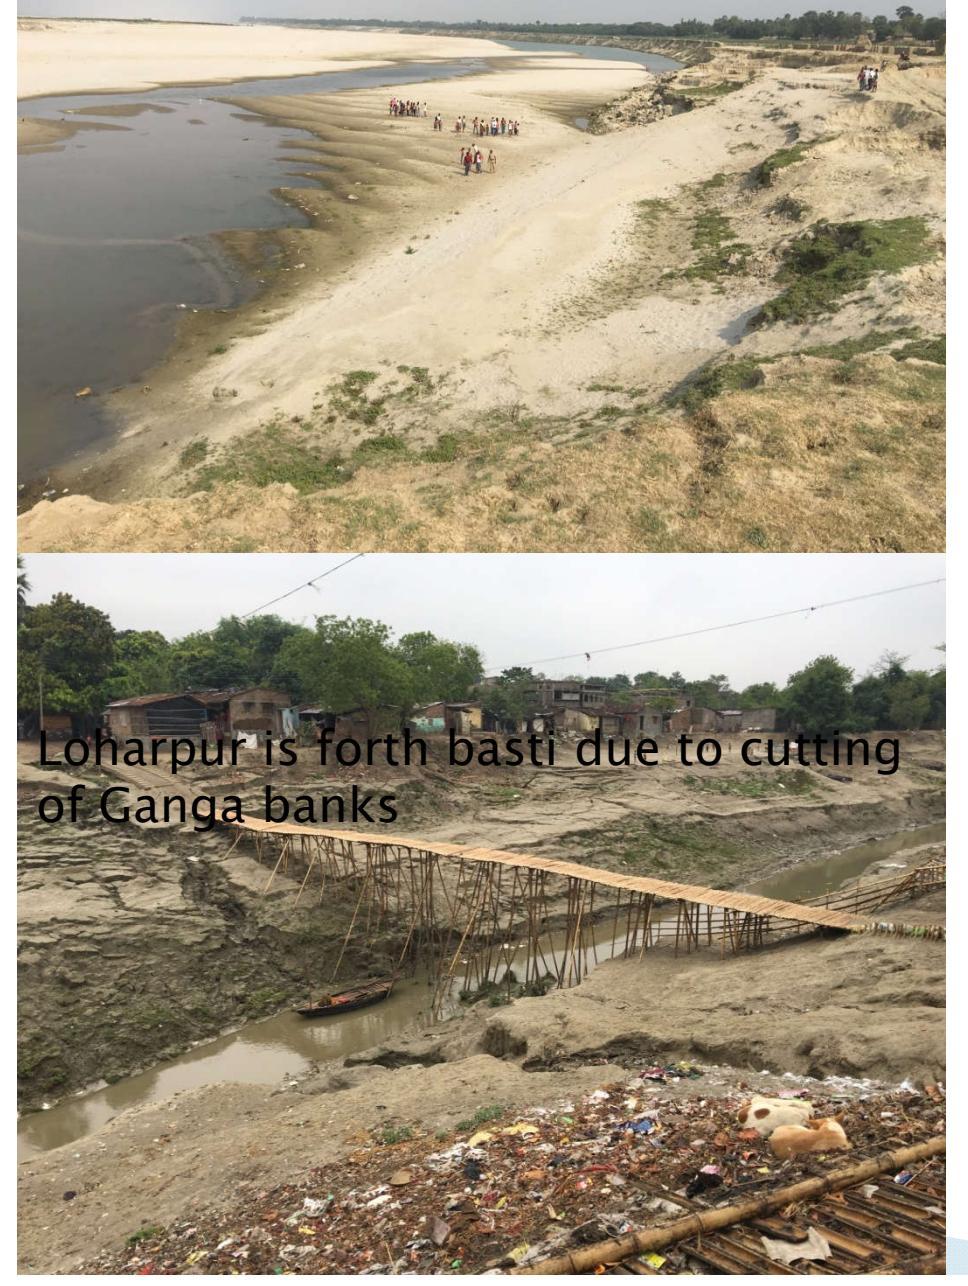
Vashipur erosion has followed by drying of river.

Loharpur where Brick making small scale furnace on the bank of Ganga river

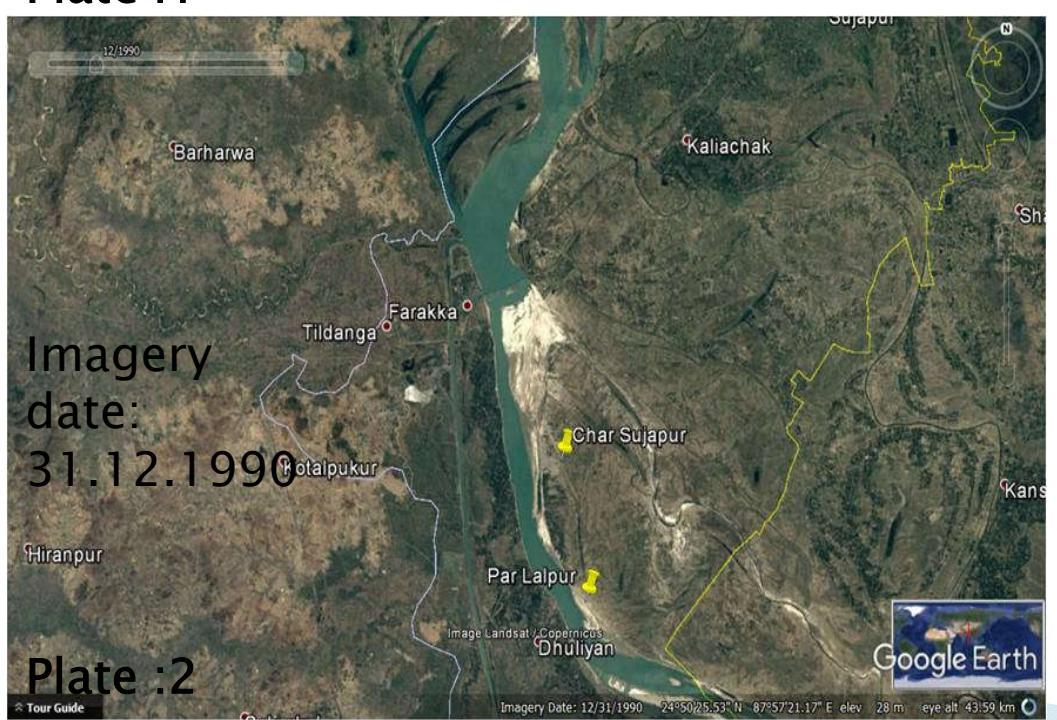
Plate :1

Imagery date: 31.12.1986

siltation was occurring just downstream of barrage on the left bank from 86-2006

- From 1986-2006, the major siltation was occurring just downstream of barrage on the left bank, which was primarily responsible for closing the mouth of a small waterway veering inland from left bank (Plate 1-3).

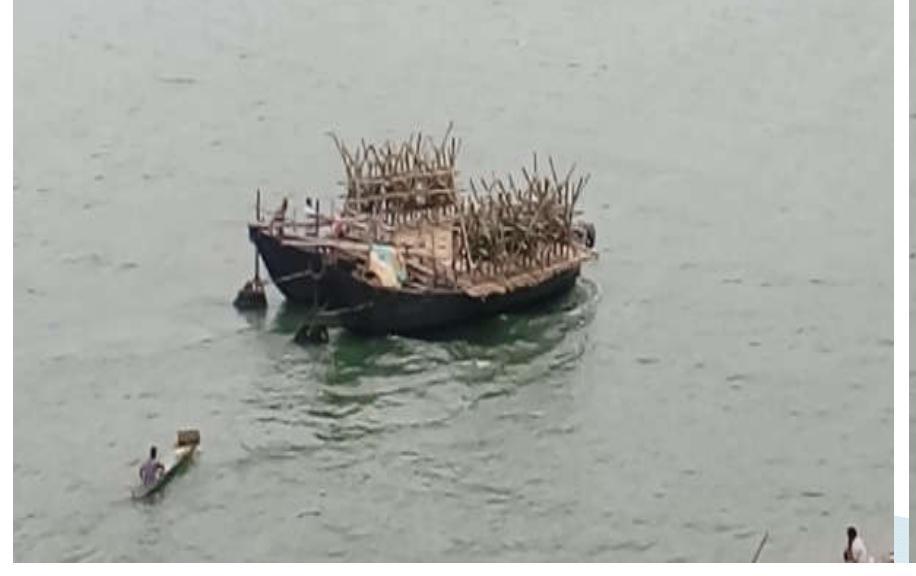
Plate5Bambooporcupinesdeploymentby irrigation dept, WB

**Plate 4** Night view of the concrete porcupines erected by Farakka Barrage Authority at Char Sujapur village

Plate 6 A bamboo porcupine is being toppled into water from a boat at the bank

•In the village Char Sujapur village bank, Farakka Barrage Authorities have installed concrete porcupine structures in series starting from the bank towards the riverbed in series of about 6-7, each bound to each other by iron rods so that they remain together (**Plate 4**).

•RCC porcupines are laid over the bank slopes and also protrude into the river section to induce siltation near the bank.

•Irrigation Department of West Bengal has just started a project on dropping bamboo porcupines near the bank at villages of Maheshpura, Mahadevnagar and other areas to help attract siltation at the bank (**Plate 5-6**).

•These structures are composed of bamboo poles bound together in definite fashion to make a cagelike structure at the lower side, wherein a few boulders have been filled that would make the structure heavy and lay at the bottom of the riverbed.

•These structures are about 5-7 ft wide, 5-6 ft high and 2-3 ft deep and are individually toppled into the riverbed from boats and are not tied to each other.

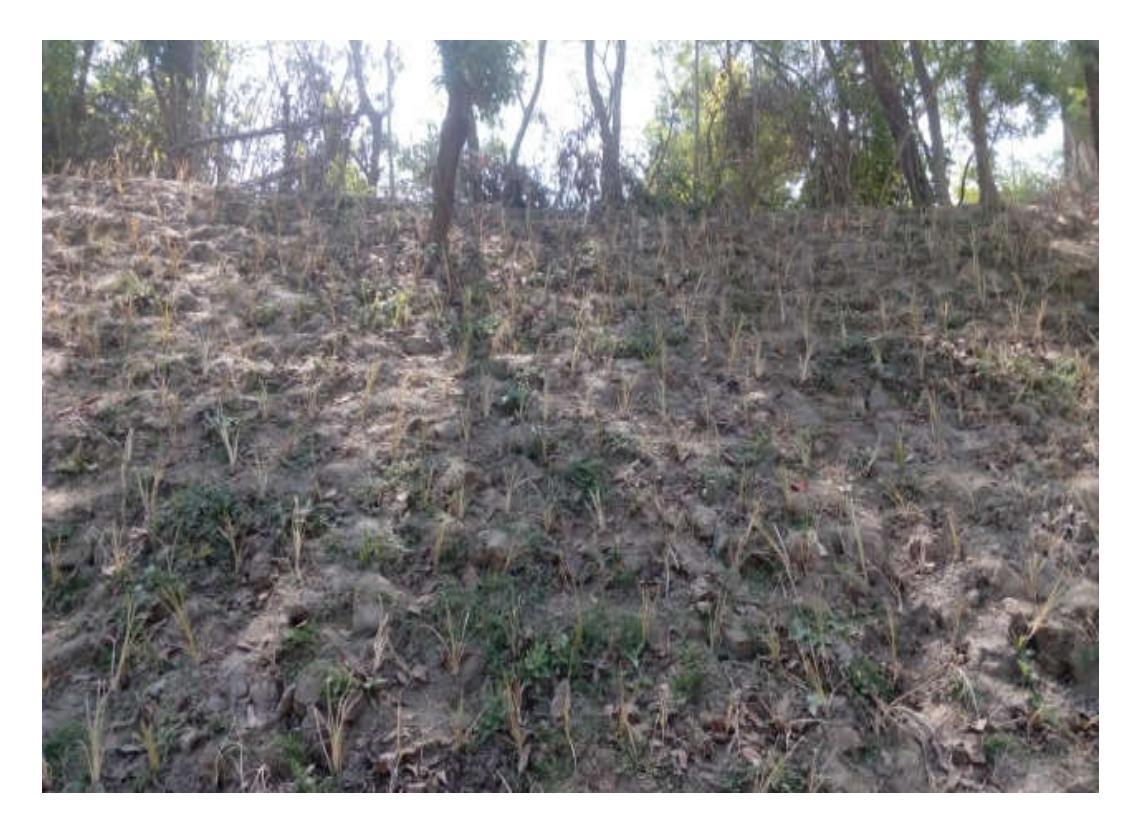
Plate 7 Frontal view of banks near Baghmari rivulet at Mahadevnagar being planted with saplings of Vetiver (*Chrysopogonzizanioides* (L.) Roberty)

•Vertiver plants have very extensive (more than 3 m in length) fibrous root system that could cover substantial soil volume and could hold soil effectively, thereby minimizing erosion

•They can grow within a high range of soil pH (3-10). Due to long roots and high tensile strength, this grass is resistant to the high velocity streams and checks the erosion.

•The plantation is just the beginning of this experimental effort that needs to be taken up on large-scale by involving more local populace. and its efficacy must be observed for at least two flood seasons.
